A Photographic Guide to the Evaluation of Hazard Trees in Urban Areas  
**TREE HAZARD EVALUATION FORM** 2nd Edition

Site/Address: 988 SUMMIT AVE GEARHART  
 Map/Location: \_\_\_\_\_  
 Owner: public \_\_\_\_\_ private  unknown \_\_\_\_\_ other \_\_\_\_\_  
 Date: 9-25-23 Arborist: BAUDEN ISA#: PN0736  
 Arborist's Signature: [Signature]

Dear Don,  
Per your request I have evaluated the pine trees located on the east side of your property identified as 988 Summit Ave. on September 25, 2023.

TREE LOCATION SITE DIAGRAM

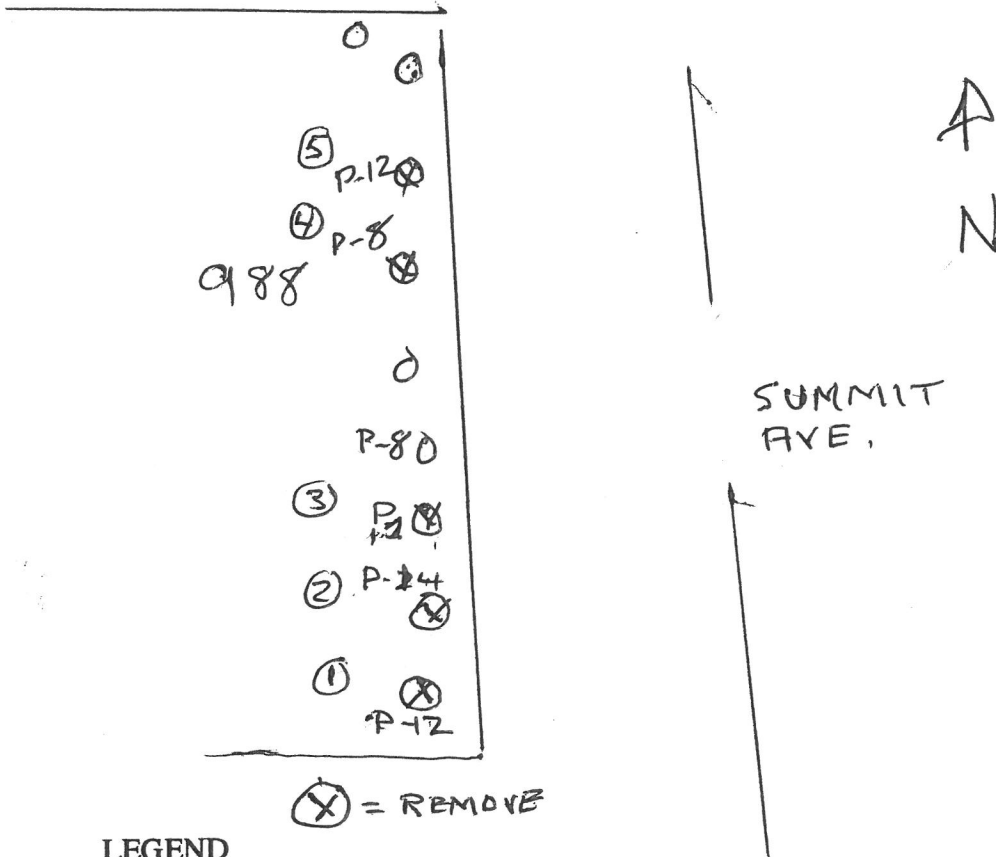
Structural problems identified; Narrow crotch angle of scaffold branch attachment to the main stem and each other that leads to failure as tree builds additional layers of tissue which is more obvious on some trees than others. It is the narrow angle of wood tissue layering in annual growth that gradually forces branches to separate from each other or from the main trunk of the tree.

The potential for failure varies depending on growth angles. I have identified 5 trees that have the highest potential for failure in the near future.

These 5 trees are marked with orange paint that have the highest level of potential failure and are recommended for removal. (refer to site diagram).

Recommendations REMOVE PER EVALUATOR
