Tree Assessment for Removal Permit Proposal

101 S Cottage Ave
Gearhart, OR 97138

Conducted By:
Bigbys Columbia Tree Service LLC.
CCB # 158562
Jason Bigby - Certified Arborist
CN: PN-6848A

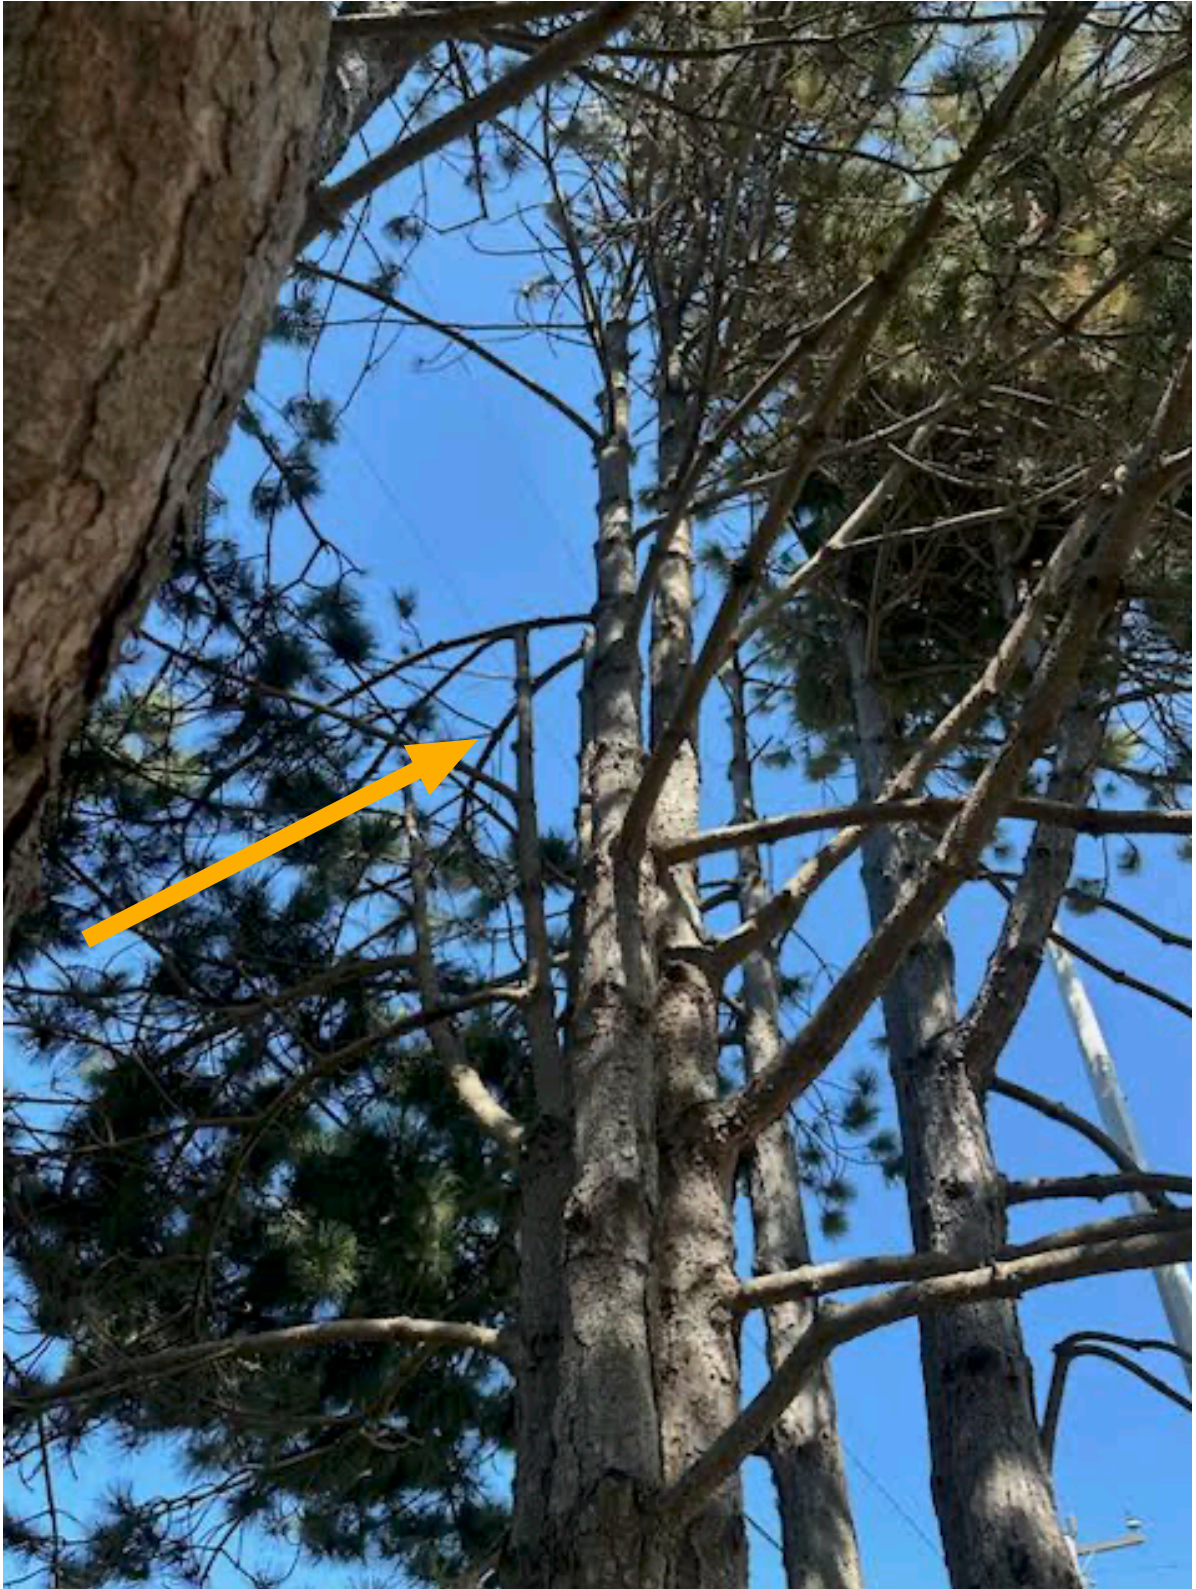
Trees have already been trimmed by Pacific Power, and will continually be.

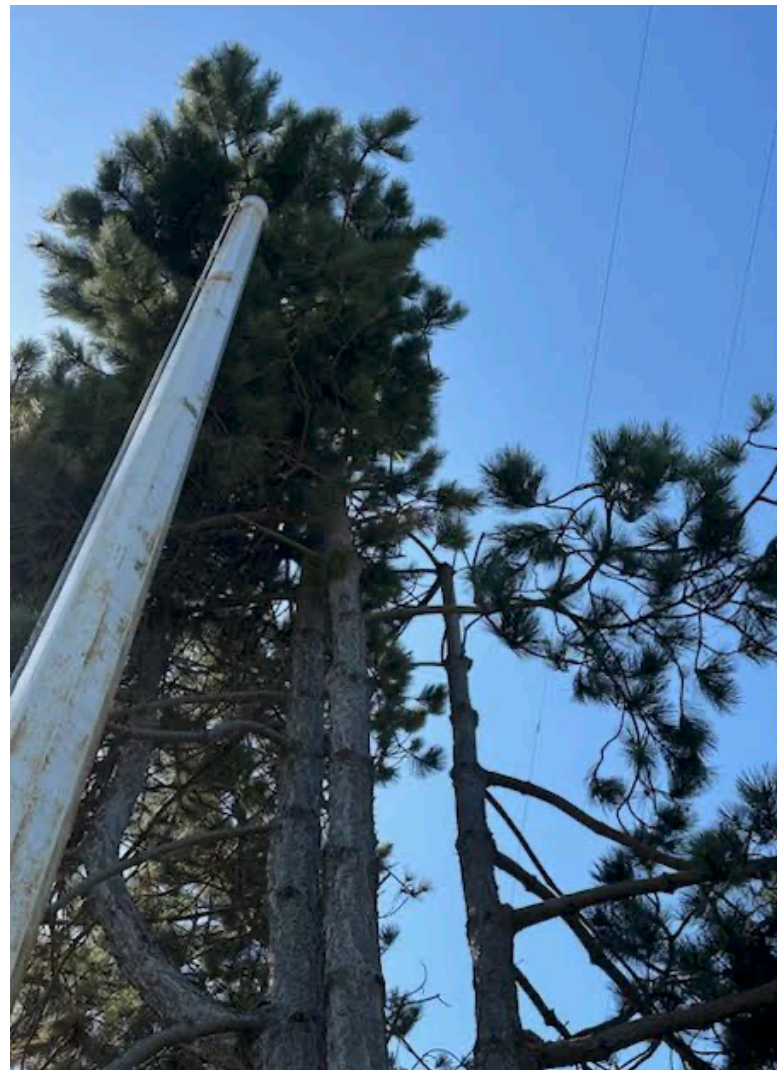
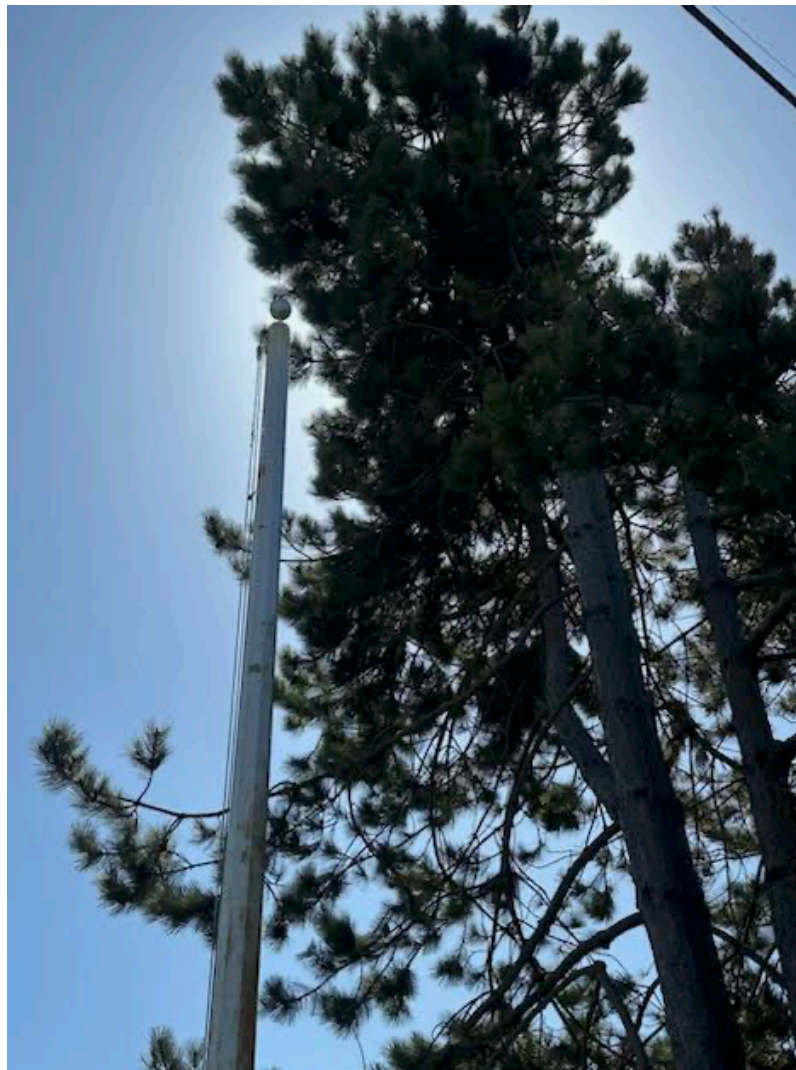
No clearance: Trees block ability to fly the flag on pole

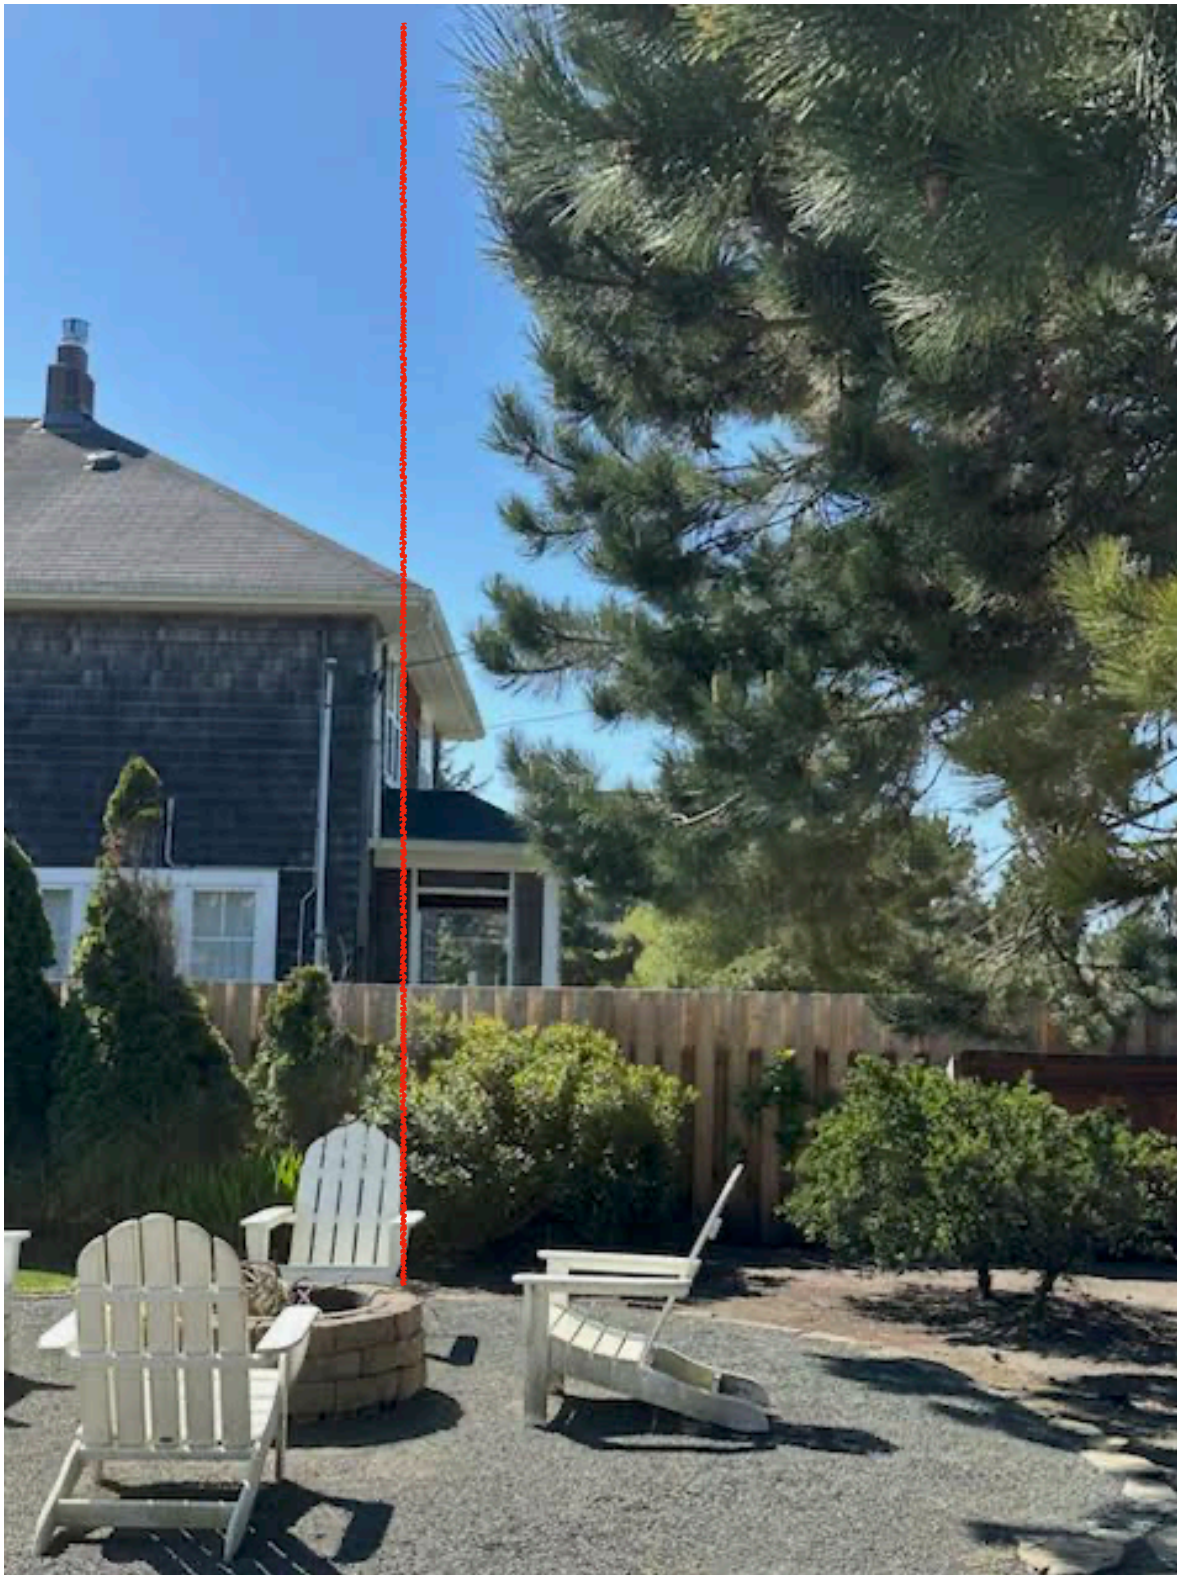
Fire Hazard: Trees are too close to the fire pit.

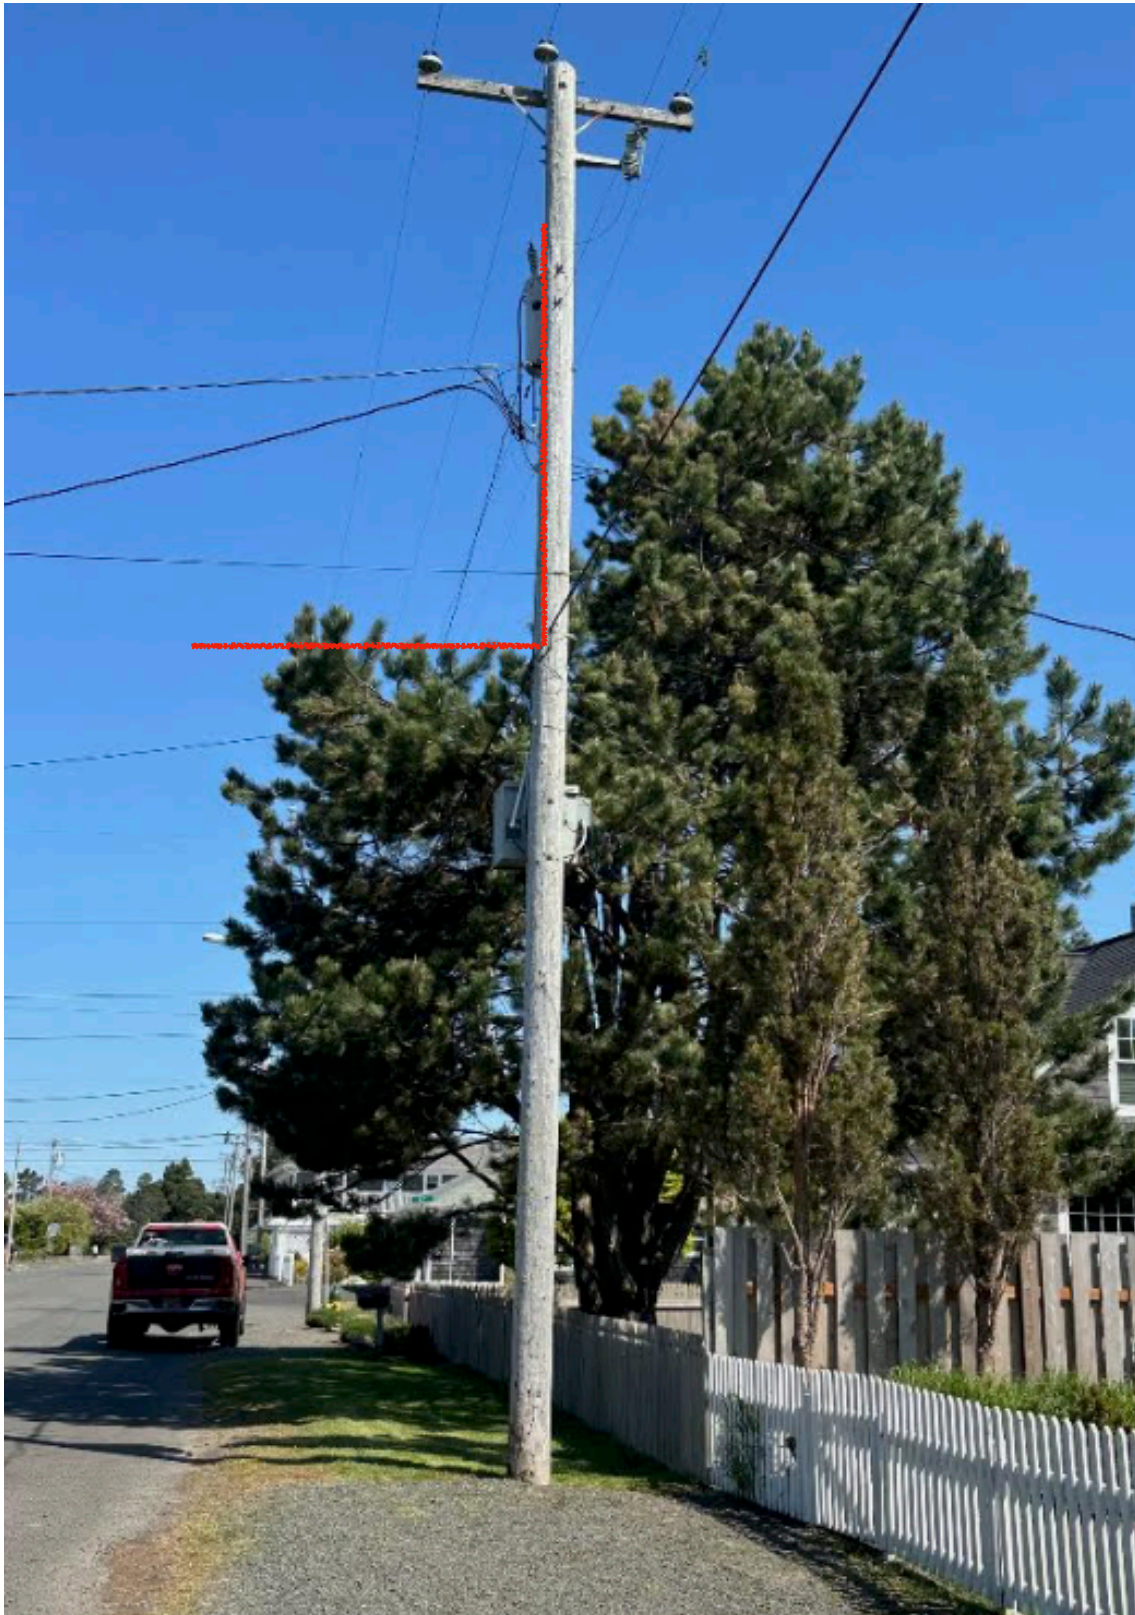
Mandatory clearance window for power lines

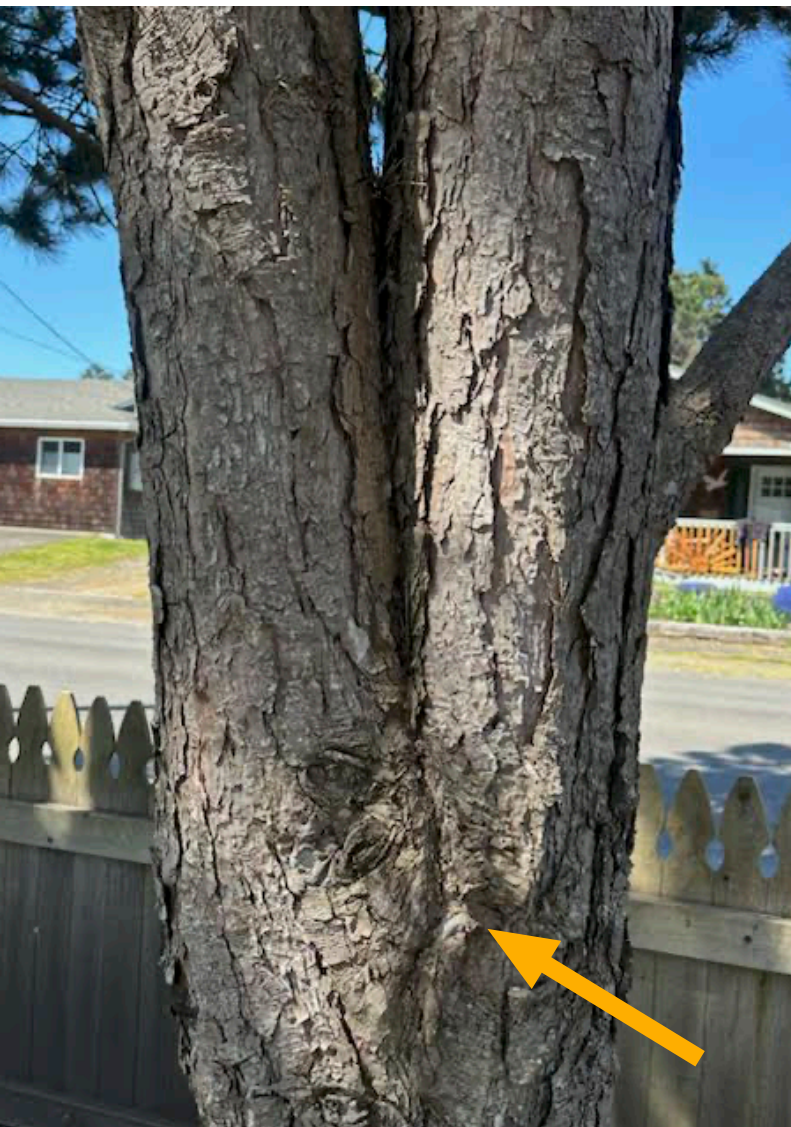
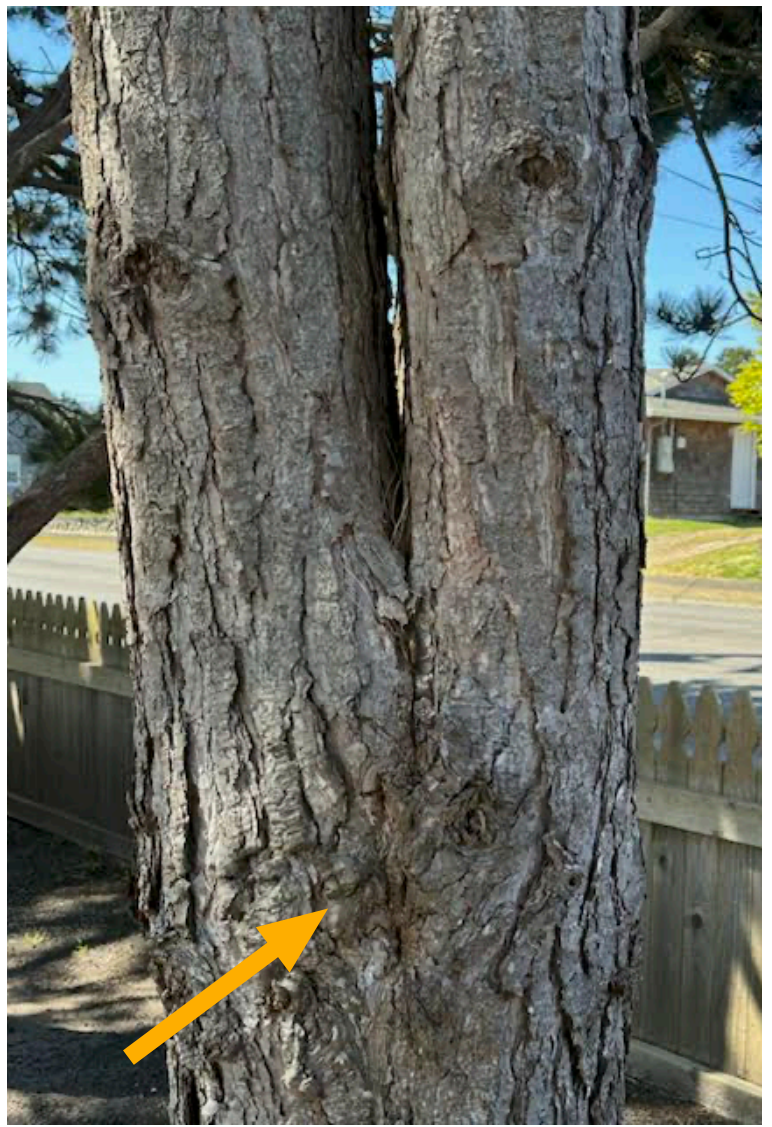
- Included bark seam
- Unknown girdling in tree

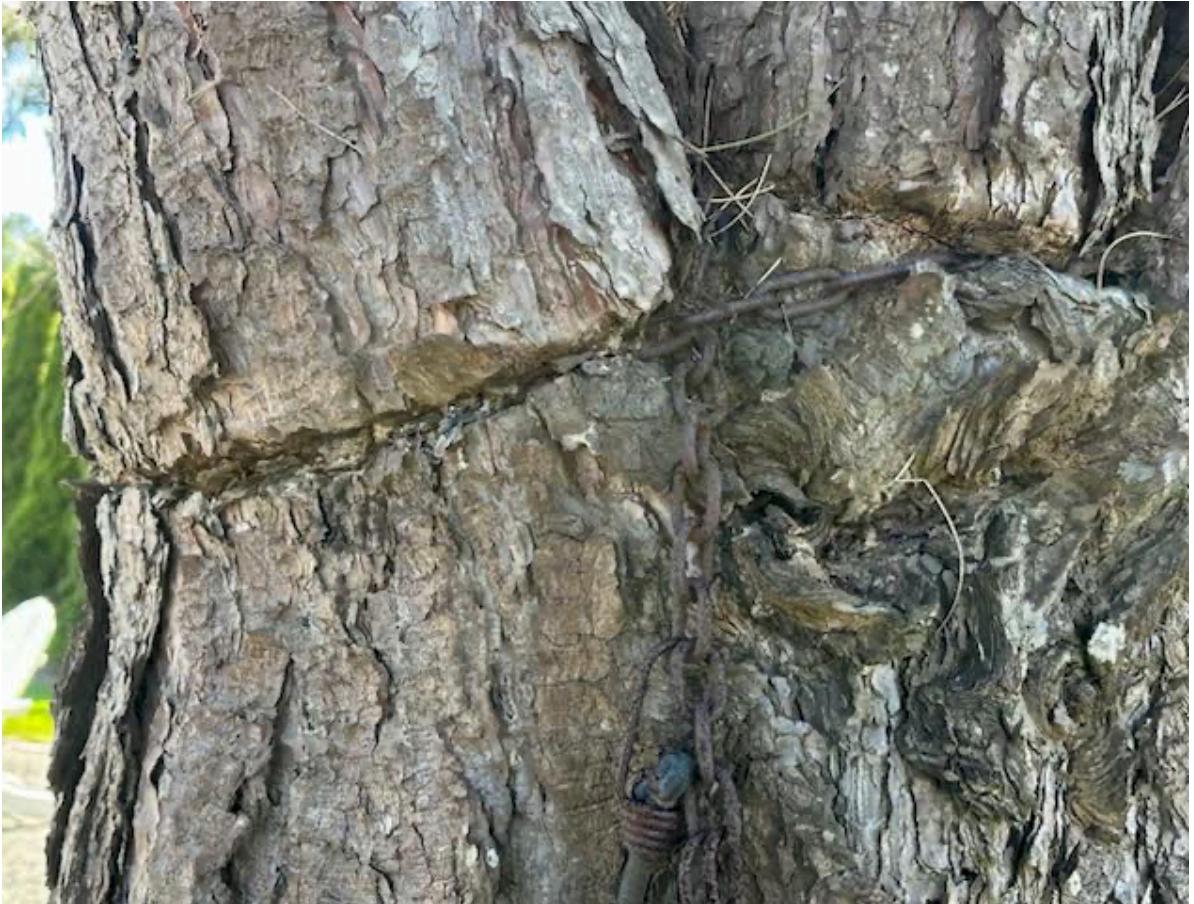
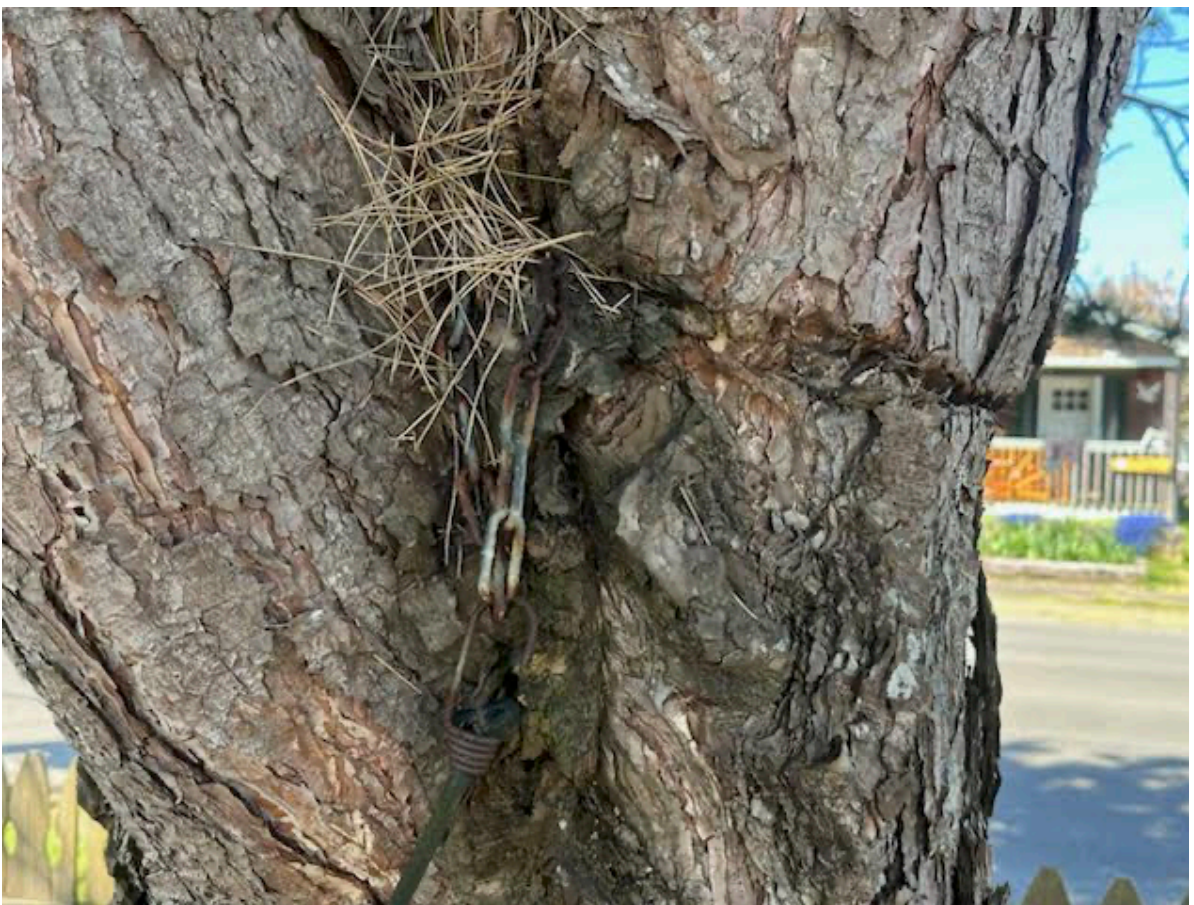
Chain growing into tree, metal hardware hanging off tree

*Leaving straps and wires on a tree after its established can lead to girdling, which is a form of strangulation. This happens when straps or wires cut off flow of nutrients and water to the tree, causing it to decline and die. *

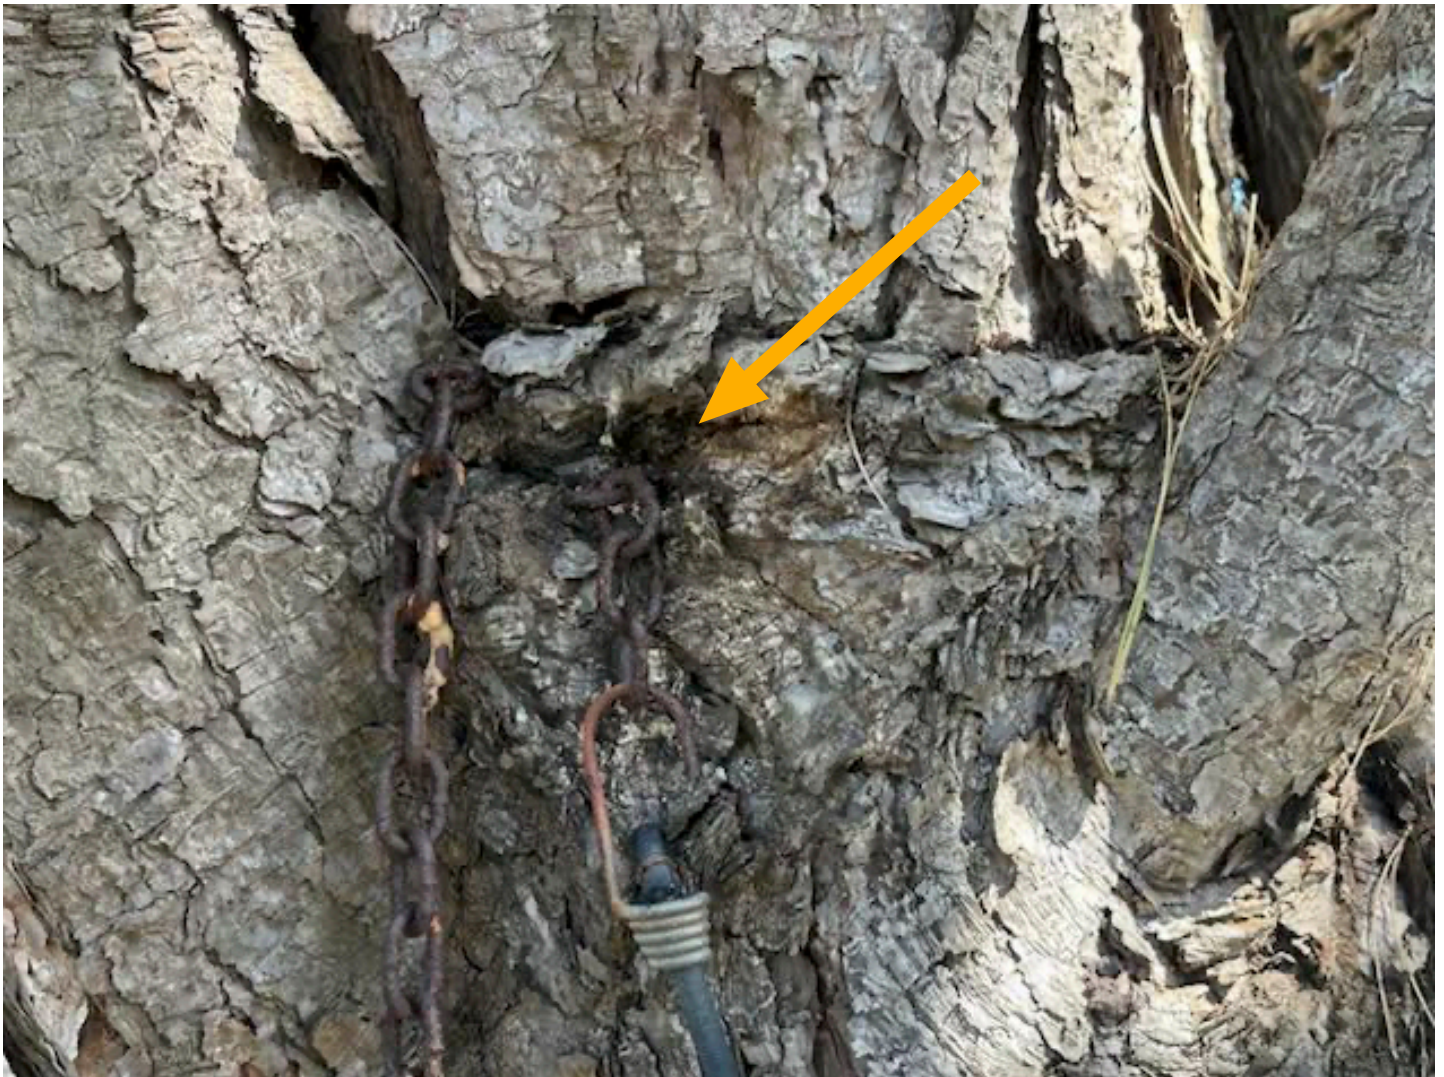
Continued: Old chain growing into tree
