Tree Assessment for Removal Permit Proposal

101 S Cottage Ave
Gearhart, OR 97138

Conducted By:
Bigbys Columbia Tree Service LLC.
CCB # 158562
Jason Bigby - Certified Arborist
CN: PN-6848A

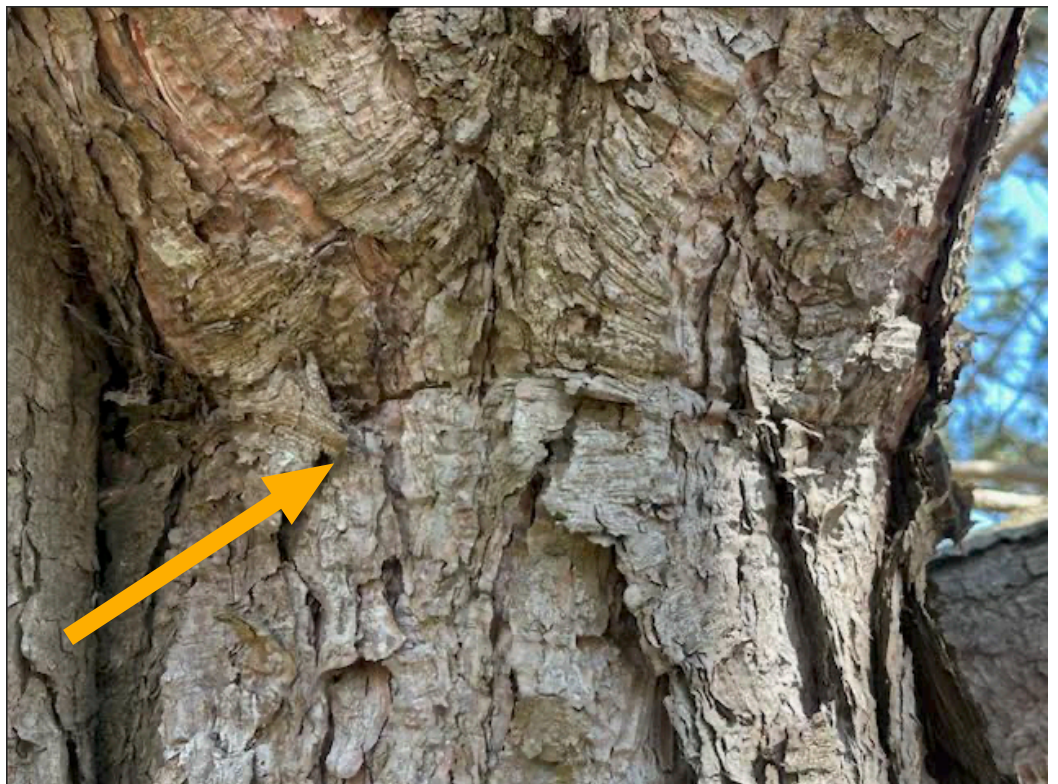
Chain growing into tree, metal hardware hanging off tree

- Trees were planted in wrong place under utility lines
- Two of the three trees have large included bark seams
- Last of the three trees has girdling and steel growing into tree trunk
- Branches present hazard located too close to fire pit

*Leaving straps and wires on a tree after its established can lead to girdling, which is a form of strangulation. This happens when straps or wires cut off flow of nutrients and water to the tree, causing it to decline and die. *
