# CITY OF GEARHART

CLATSOP COUNTY,  
OREGON

## Seismic Risk Assessment and Mitigation Plan

September 2022

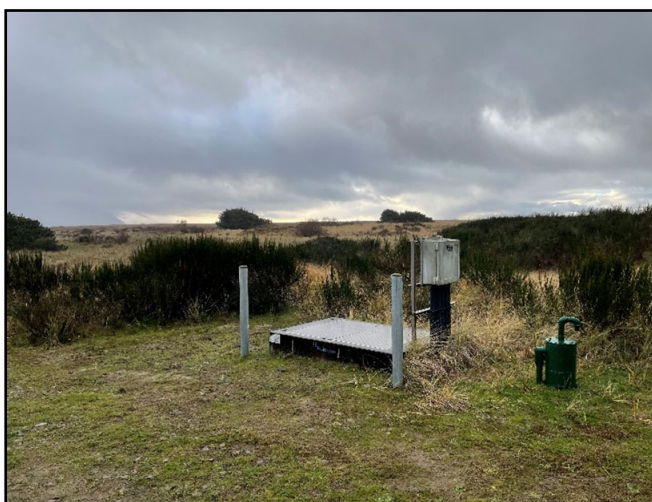
**FIGURE 2-5: GROUNDWATER SOURCES**

As noted in Section 3.1 in the Water System Master Plan, the City's groundwater wells are along the west side of the City in line with the State Park boundary, See Attachment D for locations of the wells. The City has 8 wells drilled with approval of potentially 16 wells in the well field area. Eight wells are implemented within the system with pumping equipment. (Chris R. Hyatt, RG, LHG.) The most likely disruption of water supply would be the wellheads being destroyed or inaccessible. This would likely occur during a subsidence or tsunami event. Inundation from salt water may also damage a well or make the source water unpotable. Shown in Figure 2-5 is the typical above ground features of a well including well head, valve vault, and electrical control panel.

Due to the potential inaccessibility of the well field and the imprecise ability to predict earthquakes, there is not much that can be done to prevent impacts to the well field from a tsunami. The above ground features of the wellheads and control panel are vulnerable from a tsunami. Although the initial wave from inundation may not impact the wells, the drawback of debris and saltwater inundation after the initial surcharge may damage the wells. If the wells are operable afterward, they will need to be purged and tested before being reimplemented into the system. Fortunately, the City has an intertie with the City of Warrenton and the City of Seaside for supplemental water. If the wells were out of commission for a while after a tsunami, the system could potentially still operate.

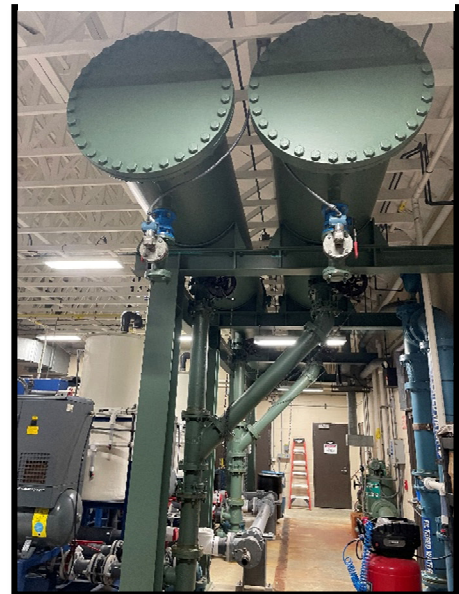
**FIGURE 2-6: RAW WATER STORAGE**

There are two recently installed ductile iron storage pipes elevated at the WTP shown in Figure 2-6. Although these tanks were installed to current seismic building code requirements, it is recommended a structural engineer analyze these elevated pipes and give any recommendations for additional seismic resiliency.
